INSPECTION REPORT
6524 Halberd Ct
Dayton OH 45459

INSPECTED BY
Greg Stowe
1st Inspection
Services
OHI.2019005171

INSPECTION DATE
📅 5/19/2026
🕒 09:00:00 AM

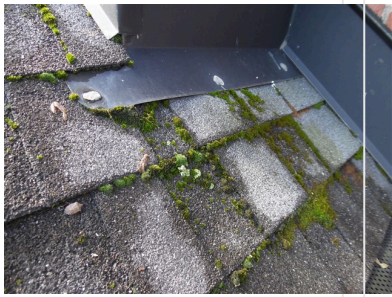
1.0 Item 4(Picture)

(2) Suggest removal of moss and or algae to prevent damages to roofing material.

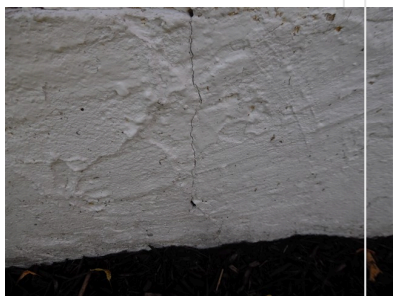
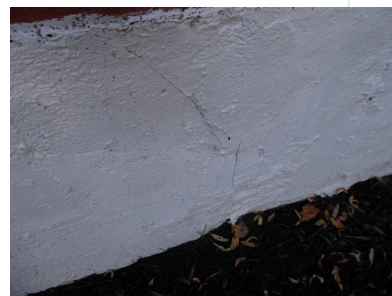
2.0 Item 1(Picture)

(1) Be sure to keep all typical settlement cracks in the visible areas of the exterior foundation walls well sealed to prevent moisture entry.

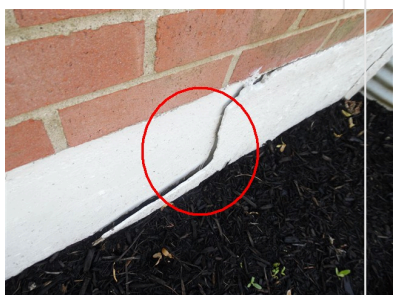
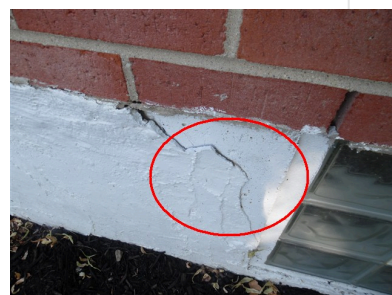
2.0 Item 4(Picture)

(2) Suggest keeping cracks and voids at the foundation parging sealed to prevent moisture causing further damage.

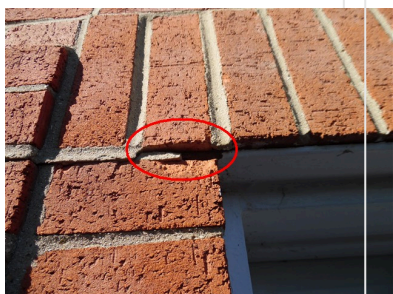
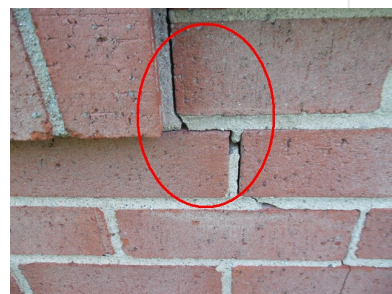
2.1 Item 1(Picture)

(1) Loose and/or missing mortar would benefit from tuck pointing to prevent moisture intrusion to the interior.

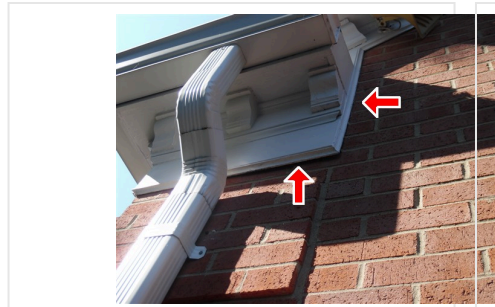
2.1 Item 4(Picture)

(2) Suggest sealing seams at exterior cladding as deemed necessary to prevent moisture entry and possible wind damage.

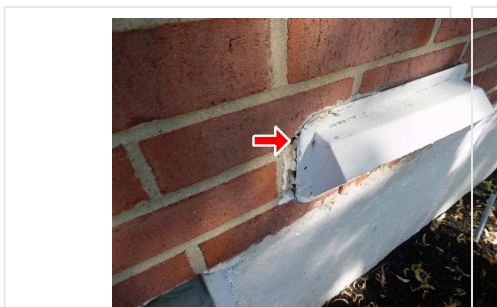
2.3 Item 1(Picture)

Recommend sealing around vent(s), to keep out moisture and pests.

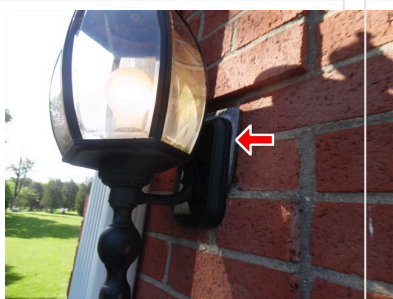
2.4 Item 1(Picture)

Recommend securing and/or sealing around light fixtures as deemed necessary to prevent moisture entry.

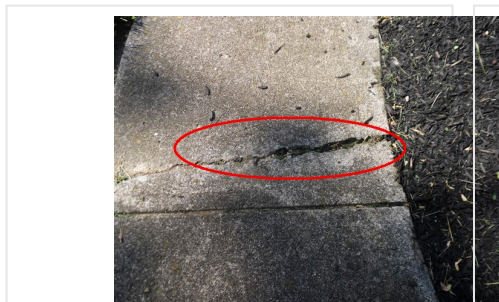
3.0 Item 1(Picture)

Filling in the sidewalk cracks will help extend its useful life.

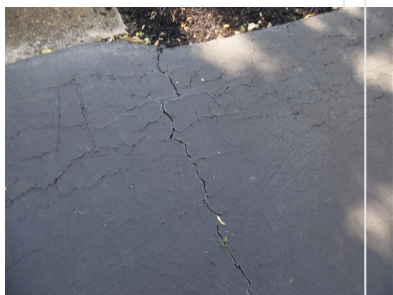
3.1 Item 1(Picture)

(1) Filling in the cracks and sealing the surface of the driveway will help extend its useful life.

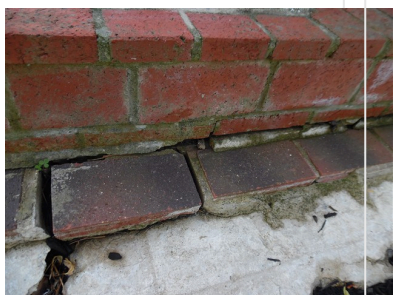
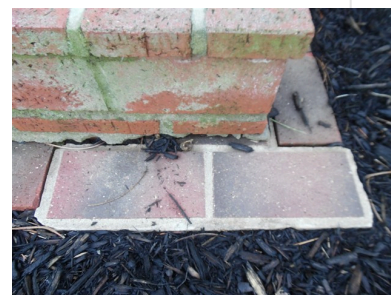
4.1 Item 1(Picture)

(1) Recommend repairing loose and missing mortar as deemed necessary by a qualified contractor to prevent further damage to the front porch..

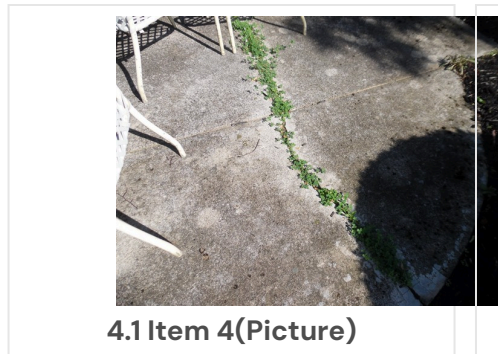
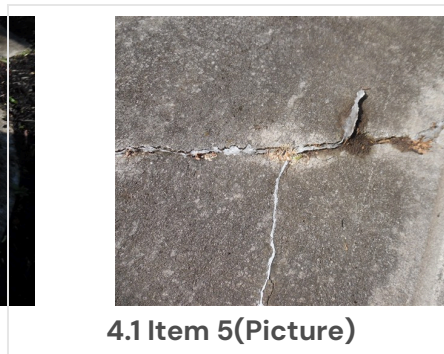
(2) Sealing the cracks will help extend the life of the patio.

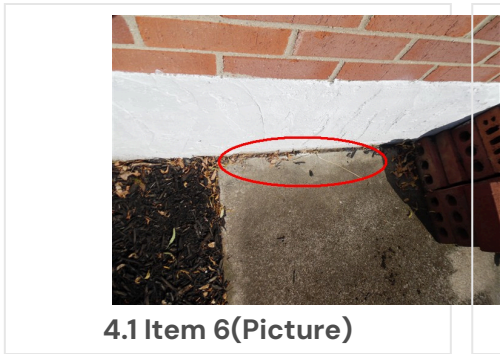
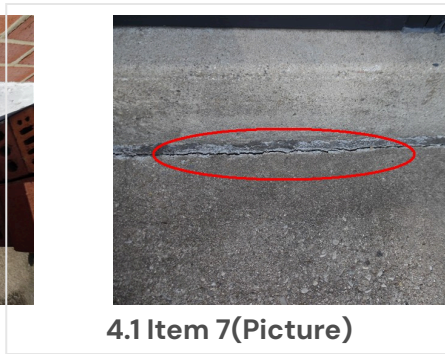
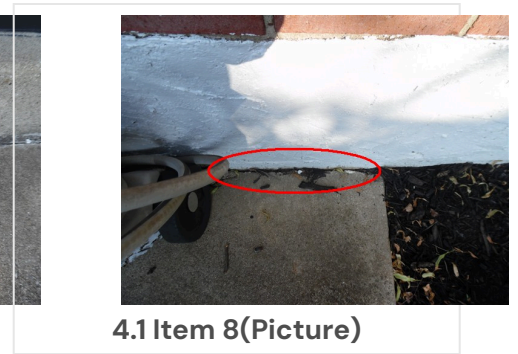
(3) Suggest sealing the seam between house and patio to help prevent water from draining along the foundation.

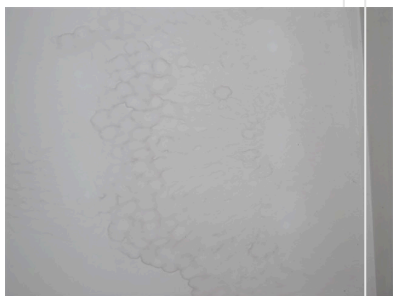
6.2 Item 1(Picture)

Water stains were noted in the garage ceiling and appeared to be dry at the time of this inspection. Suggest monitor and repairs as deemed necessary.

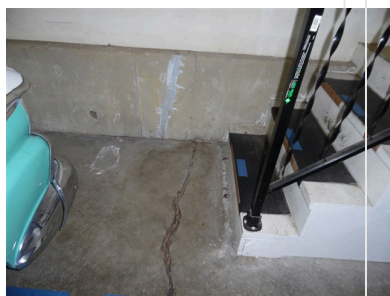
6.3 Item 1(Picture)

Sealing the cracks at floor and foundation will help prevent additional damage.

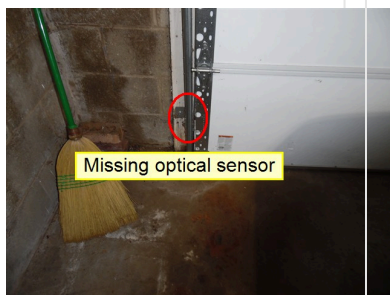
6.4 Item 5(Picture)

(2) The overhead single door optical sensors were missing. Consider having a qualified door technician install optical sensors.

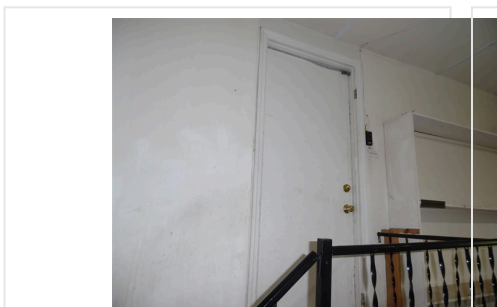
6.6 Item 1(Picture)

The garage service door was not fire rated or self-closing. Would recommend replacing with self-closing, fire rated door for safety.

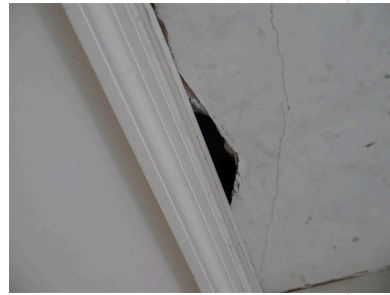
7.0 Item 4(Picture)

(2) Suggest replacing damaged attic access panel in the garage as deemed necessary for proper fire separation to the living space.

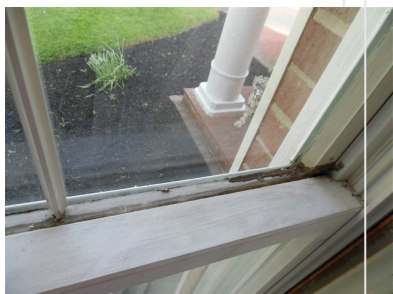
8.1 Item 5(Picture)

(2) Some of the windows were sealed and/or painted shut, would not open. Suggest repairs to insure proper operation.

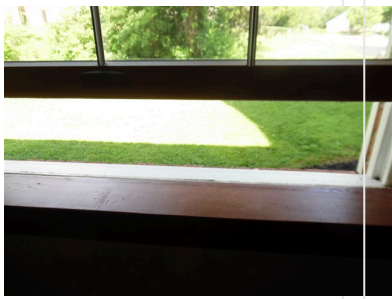
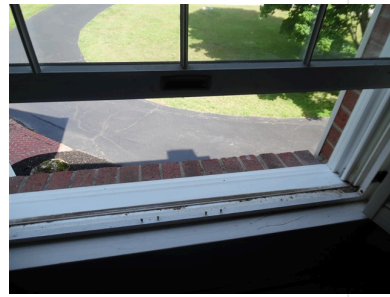
8.1 Item 8(Picture)

(3) Several windows were missing screens. Consider replacing all missing screens to keep out pest when

windows are open.

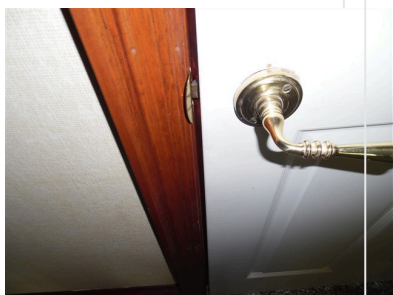
8.2 Item 4(Picture)

(2) Some interior doors failed to latch shut. Consider adjusting or replacing all faulty doors.

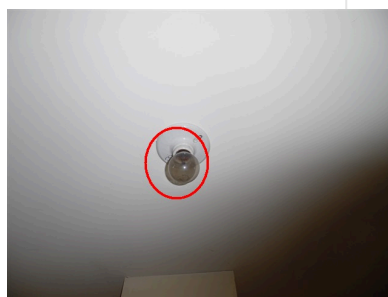
8.4 Item 7(Picture)

(3) Exposed or partially exposed lamps (bulbs) are no longer an acceptable method of lighting in closets or other storage areas. Recommend replacing light fixtures in the closets with light fixtures with covered bulbs.

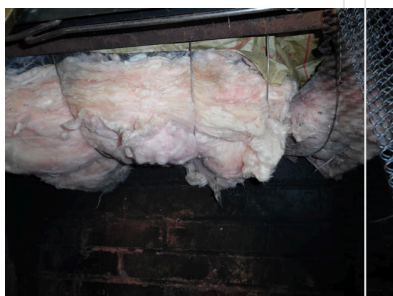
9.2 Item 1(Picture)

We observed either some creosote at dampers or sealed dampers, suggest further evaluation with cleaning and/or repairs as deemed necessary by a qualified chimney sweep before use of the fireplaces.

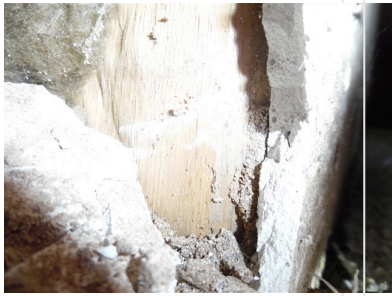
9.5 Item 1(Picture)

We observed termite shelter tubes and minor termite damage at bottom of wall studs behind damaged plaster at base of front wall in front right 1st floor bedroom, we also observed termite shelter tubes at rear foundation wall in the basement. See attached WDI report.

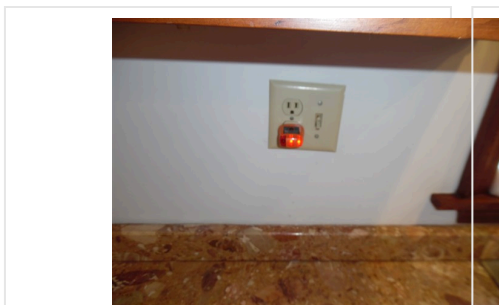
10.7 Item 1(Picture)

We recommend that you consider installing operational Ground Fault Circuit Interrupters (GFCI) in the electrical outlets located above the kitchen countertop within 6ft. of water for safety.

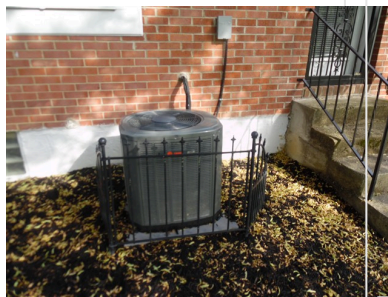
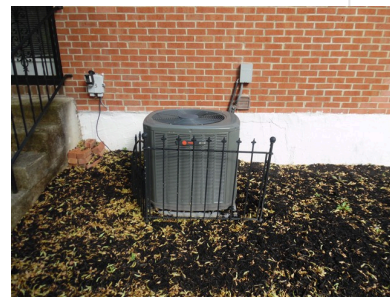
14.6 Item 1(Picture)

(1) As we observed and discussed, the a/c units appeared to be 8 years old. The average life expectancy for air conditioning units is 15–20, suggest annual service by a qualified HVAC contractor to help extend the life of the unit.

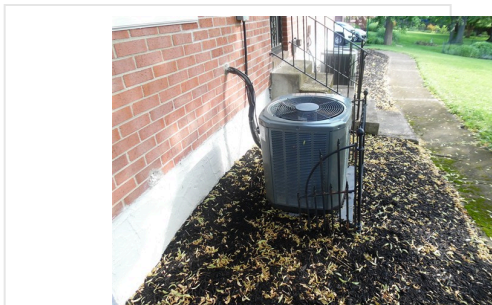
14.6 Item 3(Picture)

(2) The right A/C compressor/condensing unit was out of level. Suggest having the unit leveled by a qualified HVAC contractor. Out of level units can wear at a faster rate.

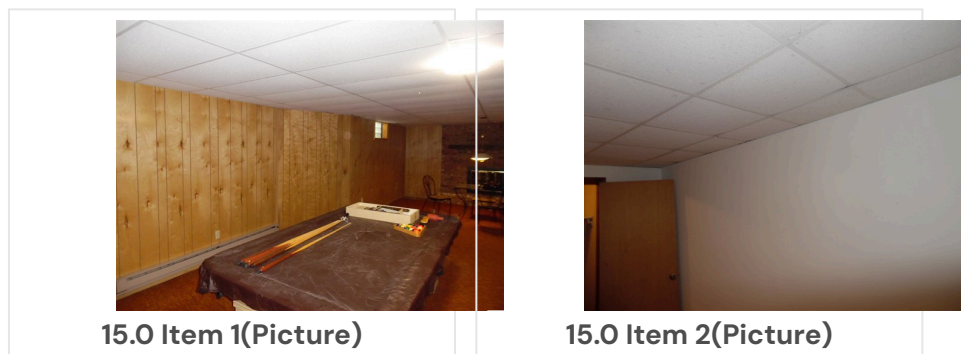
15.0 Item 1(Picture)

A large majority of the basement has finished construction on the walls, floors, ceilings, band boards, and sill plates which prevents a full, visual observation of all structural and mechanical components located above and behind the finished materials.

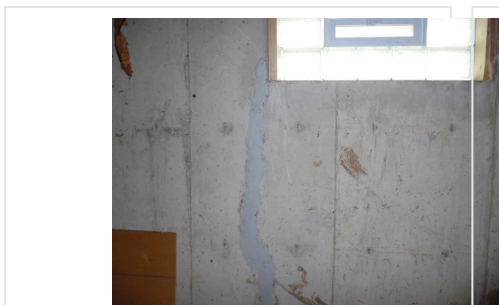
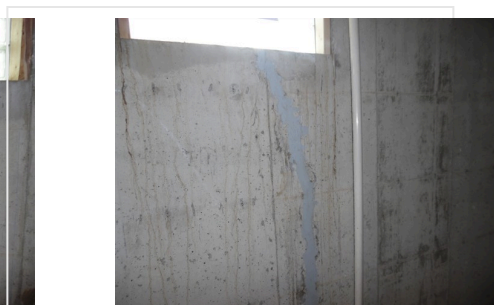
15.1 Item 1(Picture)

(1) Suggest monitor repaired cracks and repair as deemed necessary.

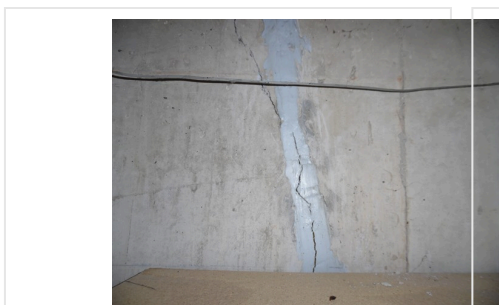
15.1 Item 3(Picture)

(2) We observed repaired cracks that were opened back up, suggest further evaluation by a qualified foundation contractor with repairs as deemed necessary.

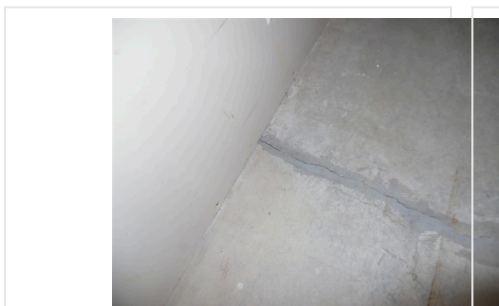
15.2 Item 1(Picture)

There where cracks on the basement floor. It is suggested that all visible cracks be sealed and monitored.
