INSPECTION REPORT
6524 Halberd Ct
Dayton OH 45459

INSPECTED BY
Greg Stowe
1st Inspection
Services
OHI.2019005171

INSPECTION DATE
📅 5/19/2026
🕒 09:00:00 AM

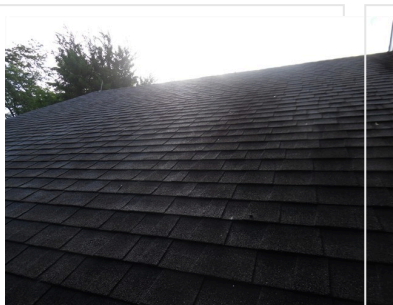
1.0 Item 1(Picture)

(1) Complimentary view(s).

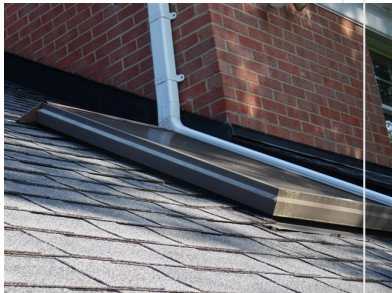
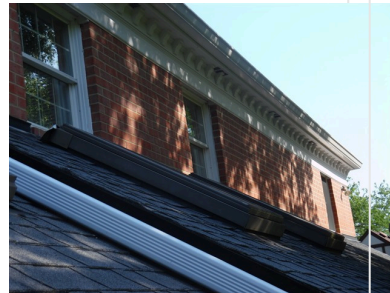
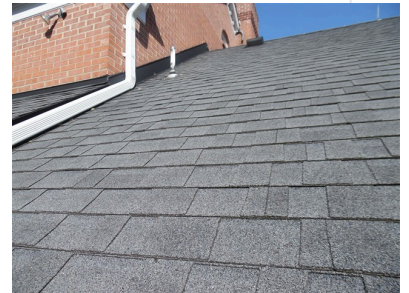
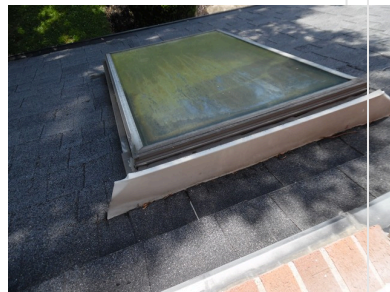
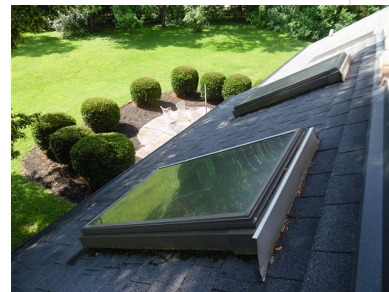
(1) Complimentary view(s).

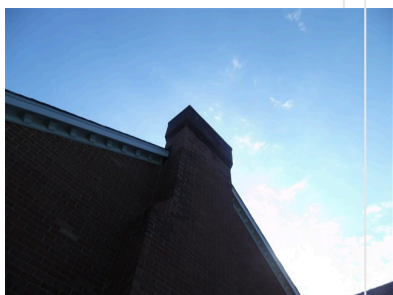
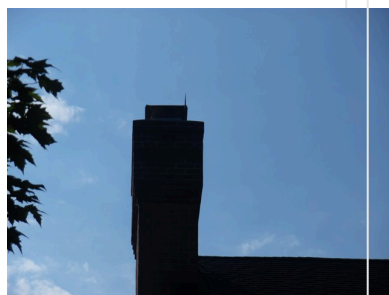
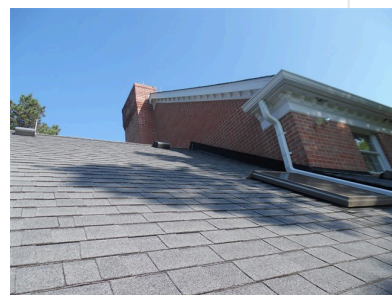
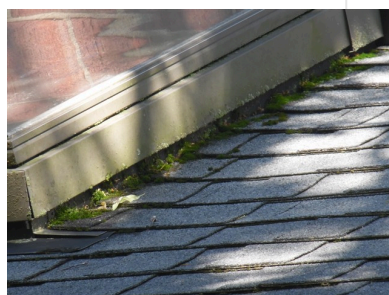
(2) The height of the chimneys prevented inspection of the chimney crown and cap.

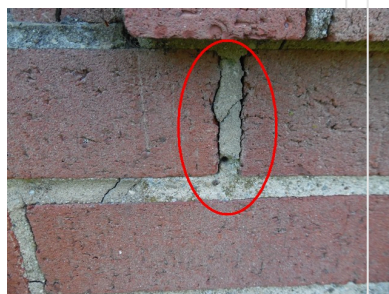
2.1 Item 2(Picture)

(1) Loose and/or missing mortar would benefit from tuck pointing to prevent moisture intrusion to the interior.

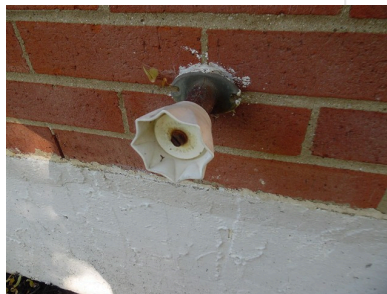
2.5 Item 2(Picture)

(2) We observed no water at rear spigot when tested, suggest repairs as deemed necessary by a qualified contractor.

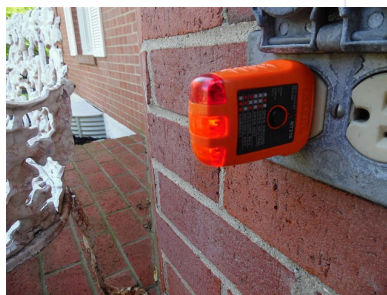
2.6 Item 1(Picture)

Complimentary view. (Note= The exterior outlets were GFCI protected and controlled by the bathroom GFCI outlet).

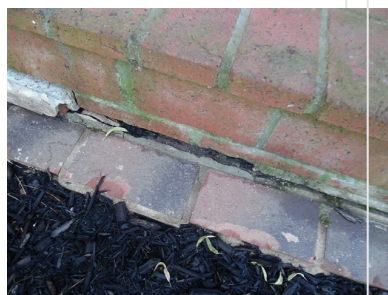
4.1 Item 2(Picture)

(1) Recommend repairing loose and missing mortar as deemed necessary by a qualified contractor to prevent further damage to the front porch..

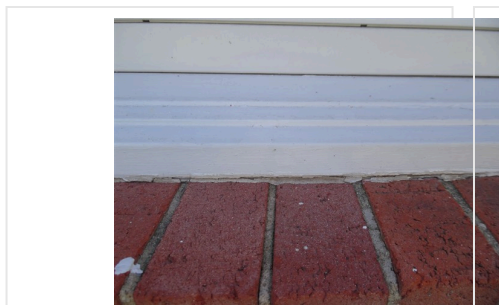
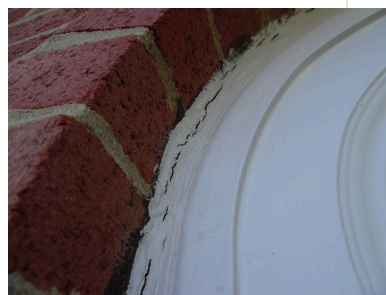
(2) Suggest keeping windows and exterior doors well caulked to help protect them from the elements.

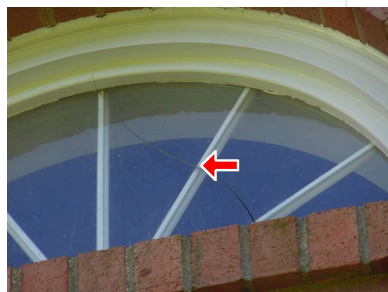
5.0 Item 7(Picture)

(3) Glass appeared to be cracked, suggest repairs as deemed necessary by a qualified window contractor.

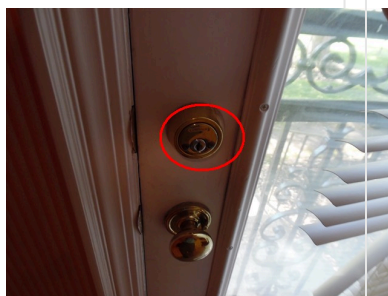
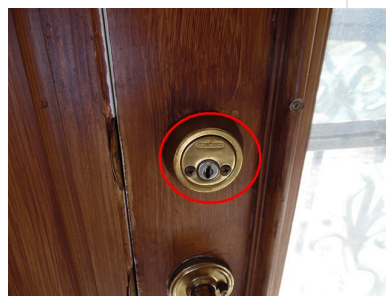
(2) Doubled keyed deadbolt locks at entry doors are considered a fire safety hazard. Recommend installing a single key deadbolt, or at a minimum keeping the key by the door.

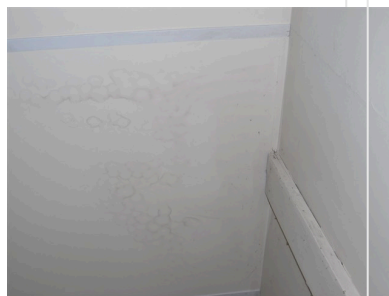
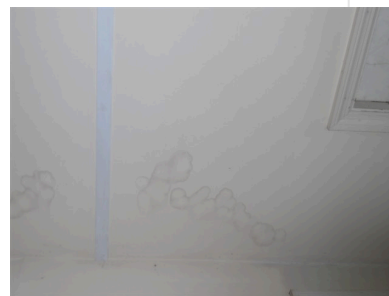
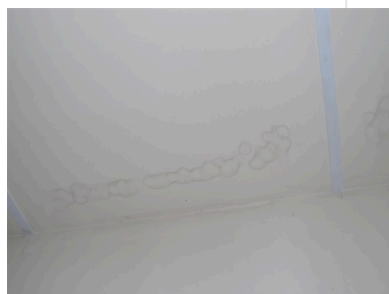
Water stains were noted in the garage ceiling and appeared to be dry at the time of this inspection. Suggest monitor and repairs as deemed necessary.

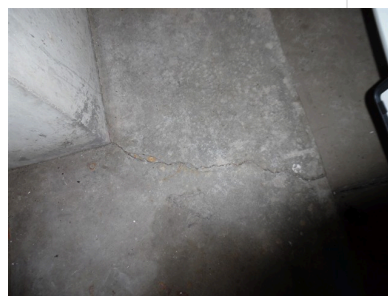
6.3 Item 2(Picture)

Sealing the cracks at floor and foundation will help prevent additional damage.

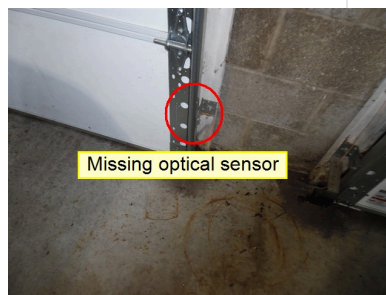
6.4 Item 6(Picture)

(2) The overhead single door optical sensors were missing. Consider having a qualified door technician install optical sensors.

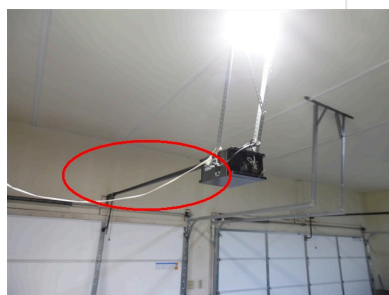
6.4 Item 7(Picture)

(3) At this time, we observed that the overhead door is connected by an extension cord to the wall outlet. Although the opener is operational at this time, this method of installation does not meet or exceed most local electrical installation standards.

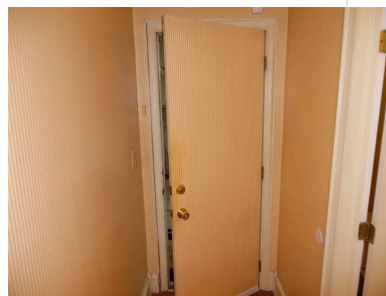
6.6 Item 2(Picture)

The garage service door was not fire rated or self-closing. Would recommend replacing with self-closing, fire rated door for safety.

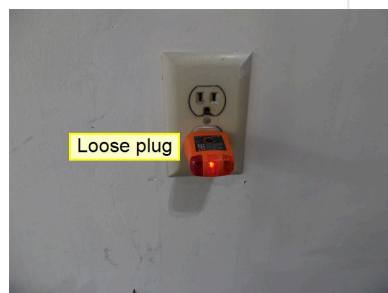
6.8 Item 3(Picture)

(2) We observed loose plug(s) in the garage when tested. Loose plugs can disrupt the flow of electricity, if the connection is not tight that causes high resistance and will cause the plug to overheat and the potential to cause arcing which is a fire hazard. Recommend replacing all outlets with loose plugs.

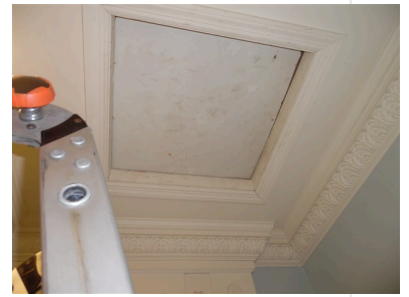
7.0 Item 3(Picture)

(2) Suggest replacing damaged attic access panel in the garage as deemed necessary for proper fire separation to the living space.

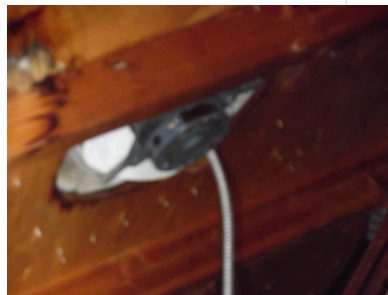
7.4 Item 1(Picture)

We observed that a thermostatically controlled power fan has been installed in the attic. As we discussed, as the scope of limitations established by [ASHI](#) and/or [NACHI](#) limits our inspection of this fan, we SUGGEST that its operation be verified prior to closing.

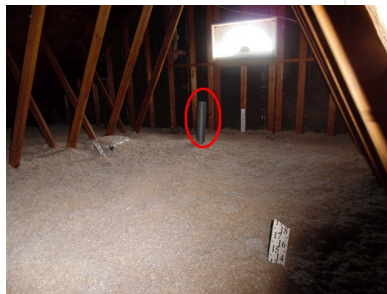
7.5 Item 1(Picture)

It is suggested that the interior vents currently venting into the attic area be extended to free airspace to help keep unwanted moisture out of the attic.

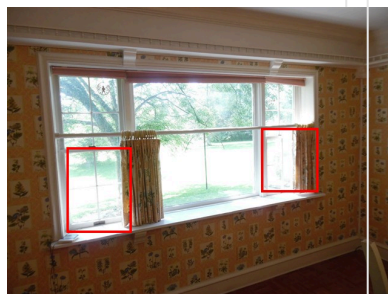
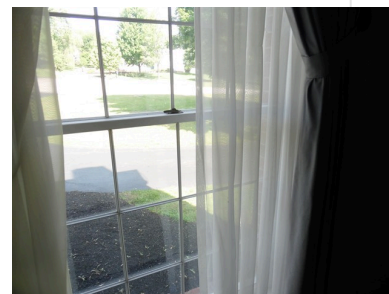
(2) Some of the windows were sealed and/or painted shut, would not open. Suggest repairs to insure proper operation.

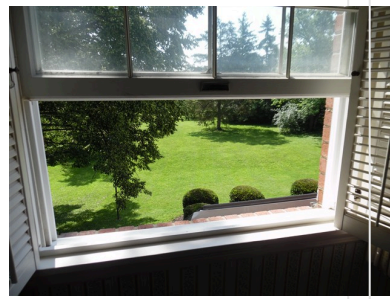
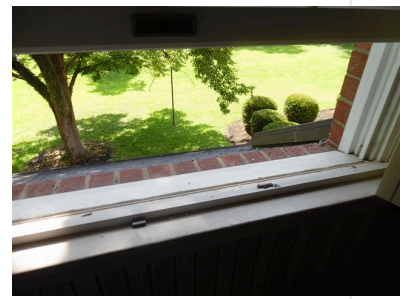
(3) Several windows were missing screens. Consider replacing all missing screens to keep out pest when

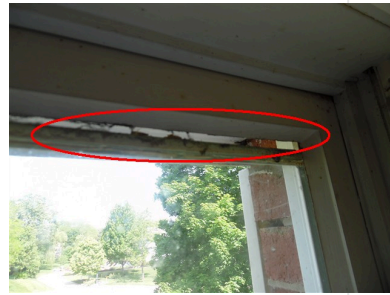
8.1 Item 12(Picture)

(4) We observed glass pane was pulled from top rail in front bedroom, suggest repairs as deemed necessary by a qualified window contractor.

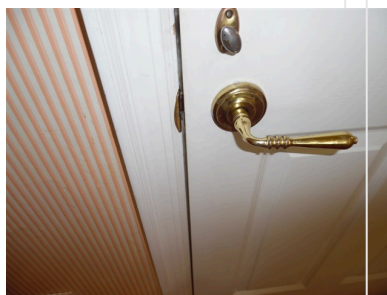
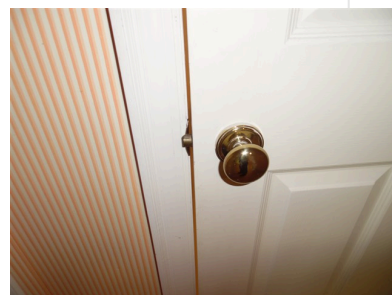
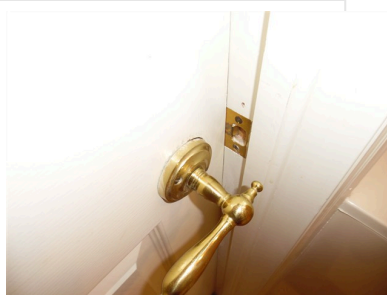
(2) Some interior doors failed to latch shut. Consider adjusting or replacing all faulty doors.

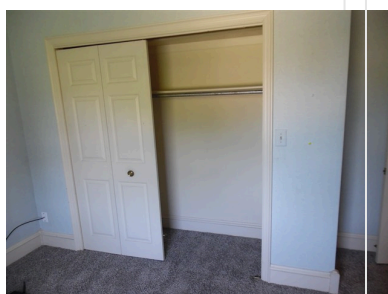
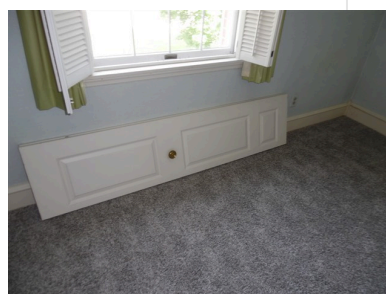
(3) Suggest installing bifold closet door.

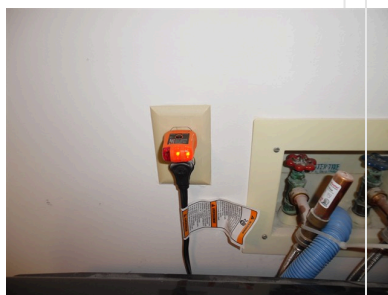
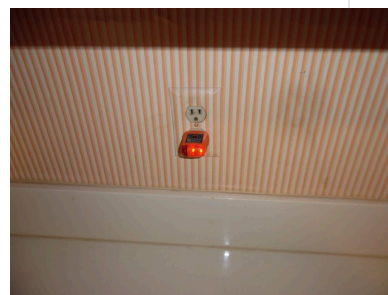
(2) Outlet to the left of the washer hookup and sink was not GFCI protected, receptacles in laundry areas must be GFCI protected. This requirement covers outlets within 6 feet of a sink or anywhere in a modern laundry room to protect against shock

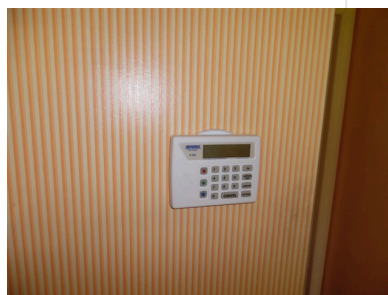
8.7 Item 1(Picture)

A security system was noted, the inspection of this systems is beyond the scope of limitations as established by the American Society of Home Inspectors. As such, specific questions regarding the operation, maintenance, etc. of this system should be directed to a qualified personnel familiar with this applications.

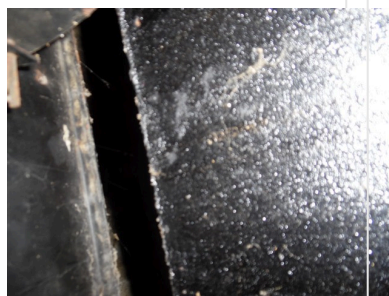
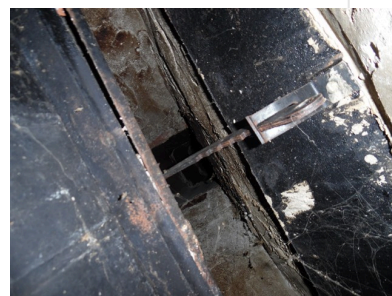
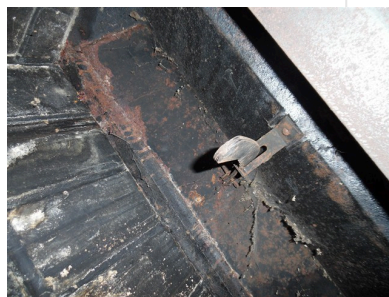
We observed either some creosote at dampers or sealed dampers, suggest further evaluation with cleaning and/or repairs as deemed necessary by a qualified chimney sweep before use of the fireplaces.

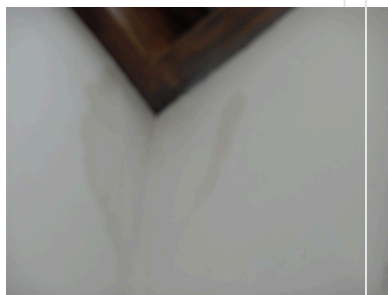
(2) We observed water stains at kitchen skylight and were dry at the time of the inspection, suggest monitor and repair as deemed necessary.

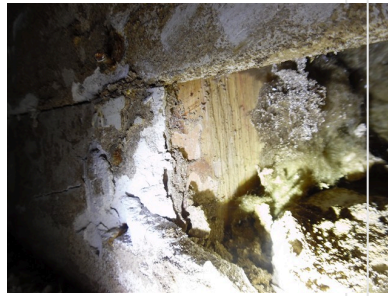
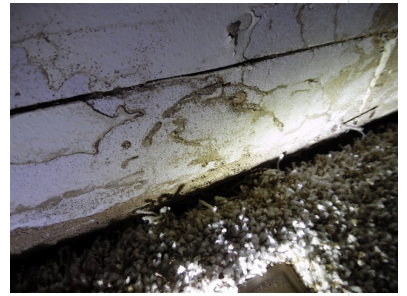
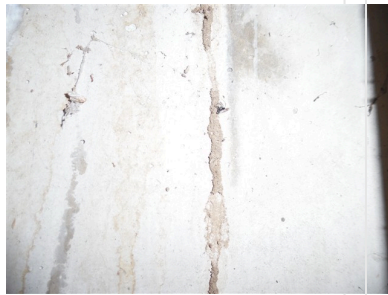
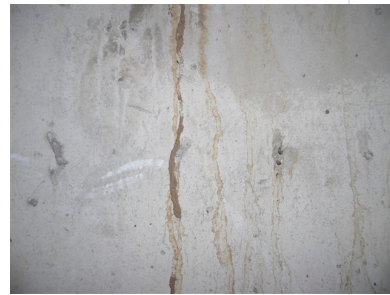
We observed termite shelter tubes and minor termite damage at bottom of wall studs behind damaged plaster at base of front wall in front right 1st floor bedroom, we also observed termite shelter tubes at rear foundation wall in the basement. See attached WDI report.

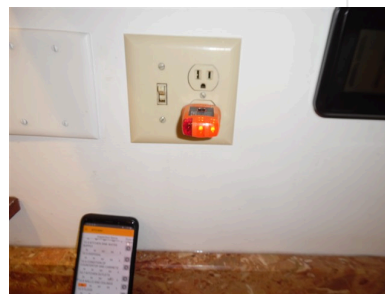
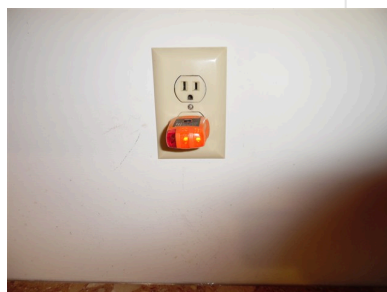
We recommend that you consider installing operational Ground Fault Circuit Interrupters (GFCI) in the electrical outlets located above the kitchen countertop within 6ft. of water for safety.

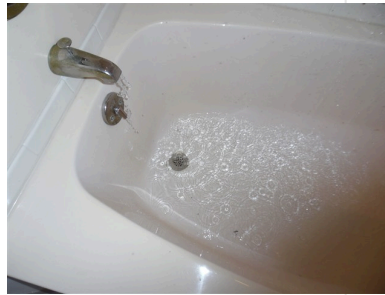
11.2 Item 1(Picture)

The bathtub appeared to drain slowly and may benefit with a professional cleaning.

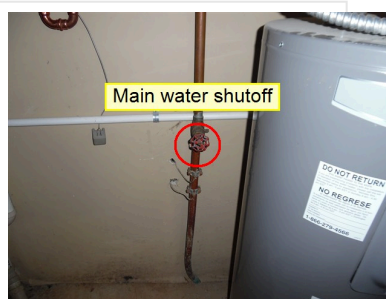
12.1 Item 1(Picture)

The main water shutoff was beside the water heater.

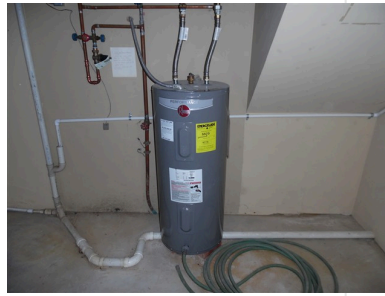
12.2 Item 1(Picture)

The water heater was 11 yrs. old. Note: With regular inspection, draining, and flushing, you can expect an

electric water heater to last anywhere from 10-15 years. We recommend annually draining and flushing water heater to help prolong its useful life.

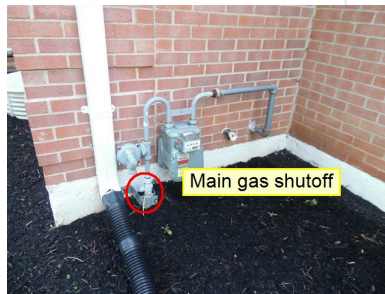
12.3 Item 1(Picture)

The main gas shutoff was at the front of the house.

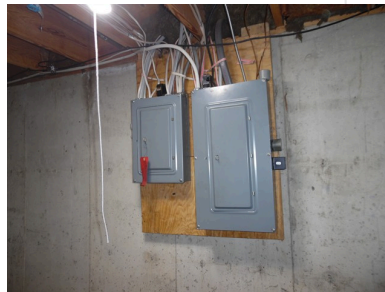
13.0 Item 1(Picture)

Main panel box was located in the basement.

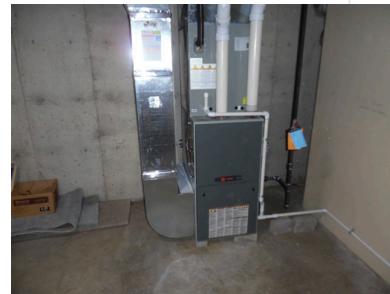
14.0 Item 2(Picture)

While the furnaces worked as designed at the time of inspection, there were no signs of recent servicing. We recommend further evaluation and servicing by a qualified HVAC technician prior to closing.

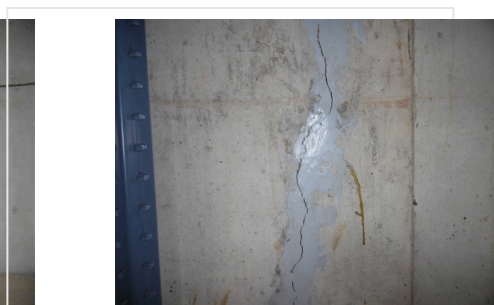
15.1 Item 4(Picture)

(2) We observed repaired cracks that were opened back up, suggest further evaluation by a qualified foundation contractor with repairs as deemed necessary.

(1) Suggest monitor repaired cracks and repair as deemed necessary.

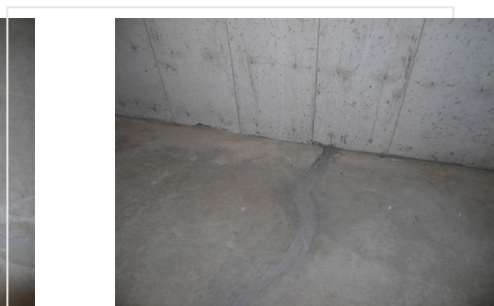
15.2 Item 2(Picture)

There where cracks on the basement floor. It is suggested that all visible cracks be sealed and monitored.
